MISCELLANEOUS PAPER S-73-42

# CONDITION SURVEY, GRAND FORKS AIR FORCE BASE, NORTH DAKOTA

P. J. Vedros, H. T. Thornton, Jr.

June 1973

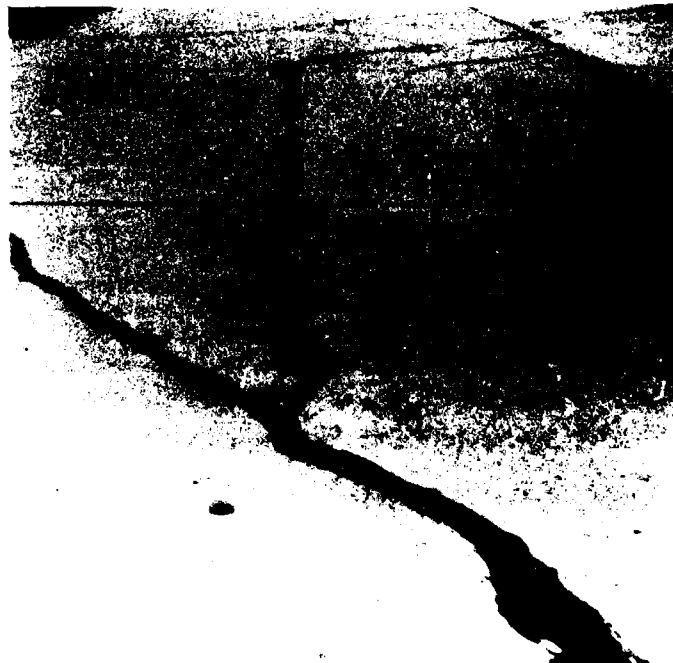
Photo 2. Cracking in outside lane of runway

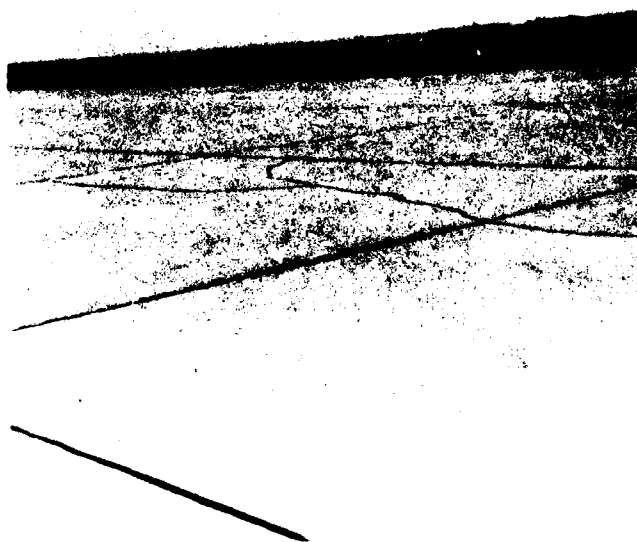
20. The warm-up apron (feature A1B) was in excellent condition, with only one transverse crack observed. The missile loading ramp (feature A15B) was in excellent condition, with only about 5 percent of the slabs containing major defects. Some slabs at the entrance to the loading ramp contained longitudinal cracks (photo 6).

Photo 6. Cracking in slabs of taxiway C at  
entrance to missile loading ramp

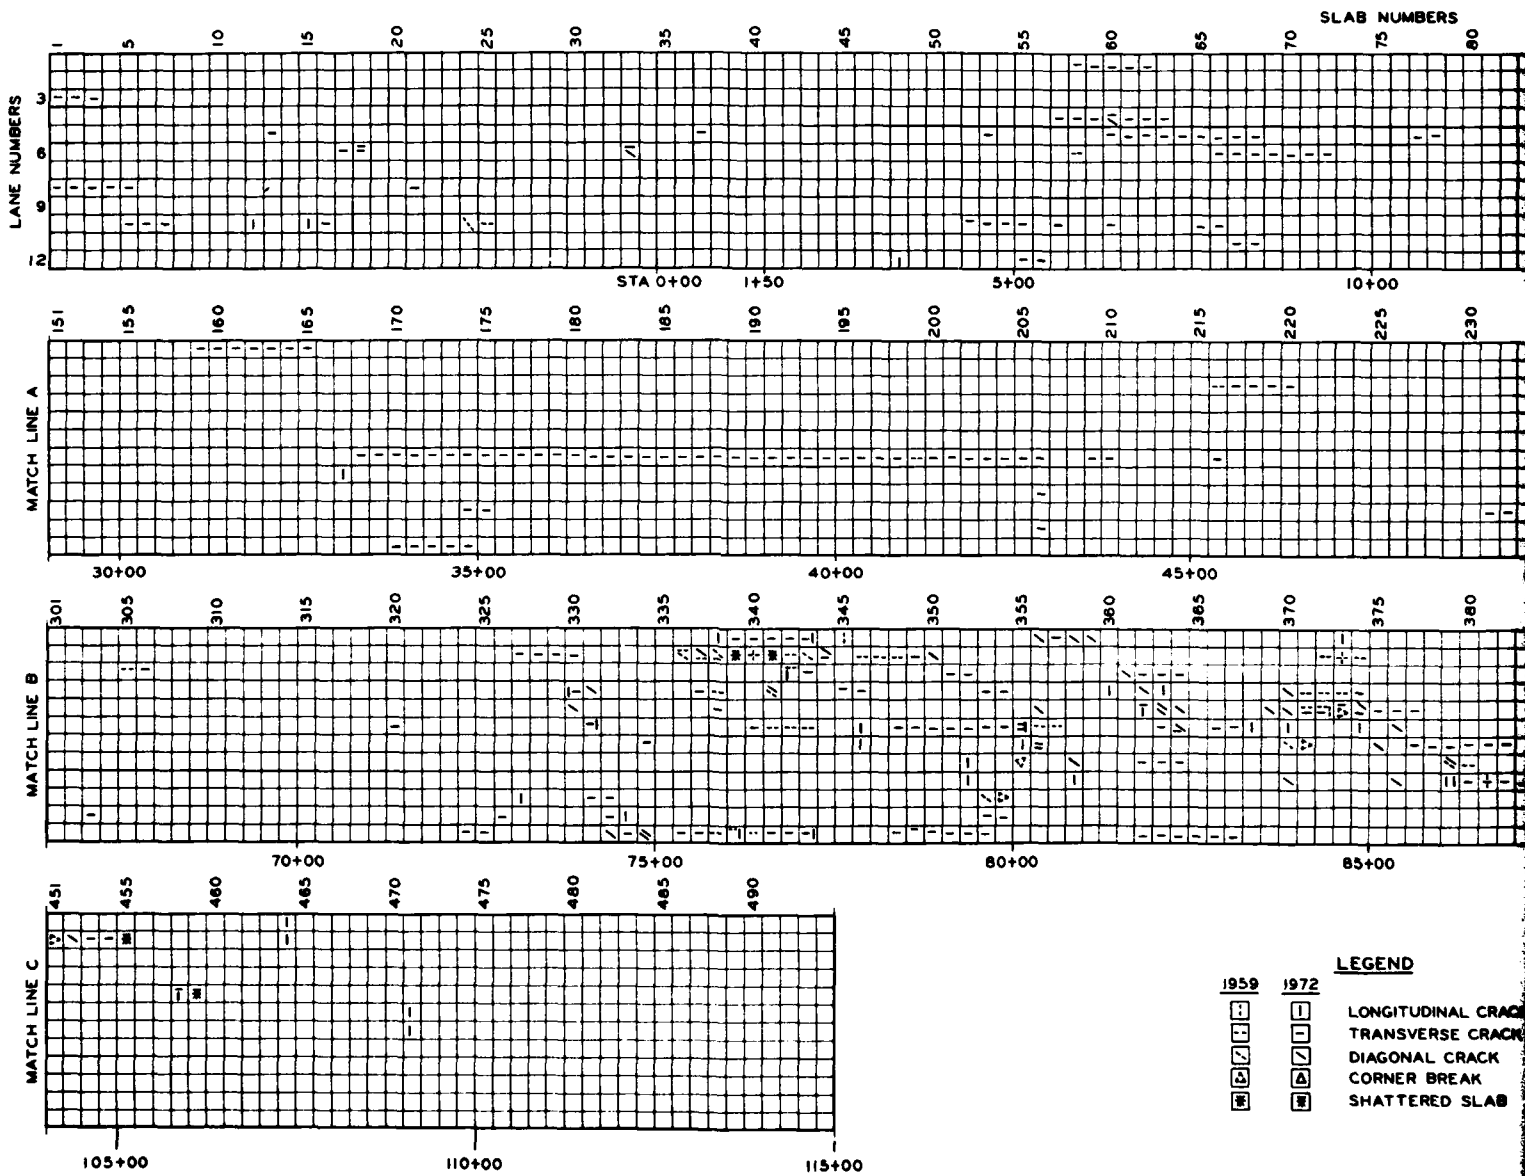
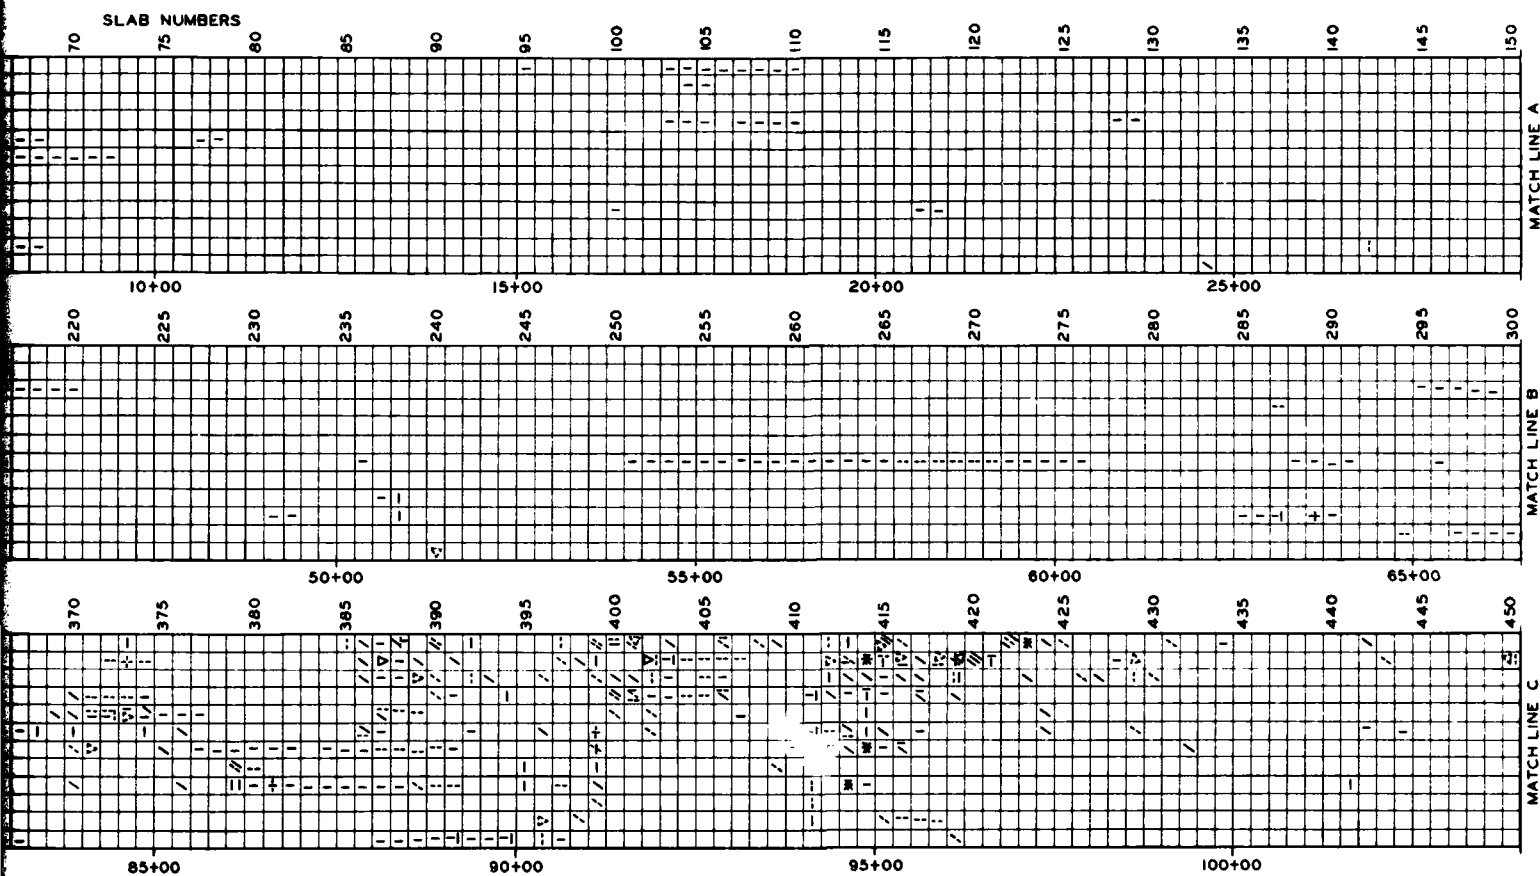
GRAND FORKS AFB, NORTH DAKOTA  
**PROGRESSION OF MAJOR DEFECTS  
 ON NORTH-SOUTH RUNWAY**

12. The greatest amount of cracking was occurring in the runway extension (4000-ft extension to the north (17) end of runway) between sta 75+00 and 98+00. It was concluded from the crack surveys in 1959 that the uncontrolled cracking was caused by nonuniform frost heave and subsidence of undisturbed soils.

23. Runway. In April 1958, considerable cracking was observed on the 4000-ft runway extension (features R4C, R5B, R6A, and R9D) which had been constructed in 1957. To determine the cause of this cracking, surveys were conducted in 1958 and 1959 (see paragraphs 11 and 12). As is noted in paragraph 13, cracks in the interior portion in this area of the runway (feature R4C) increased by approximately 75 percent since the earlier surveys. Most of the cracking was outside of the lanes subject to the most traffic, and nonuniform heave is considered to be the most probable cause. Records indicate that the original design called for a 34-in. sand (F2\*) subbase under a 19-in. pavement and 19-in. base course. However, due to depletion of the sand source, natural subgrade material (F3\*\* and F4†) was used for the subbase with F4 material removed to a 72-in. depth. This construction resulted in a variable F3 or better subbase, and subgrade soils within the depth of frost penetration are indicated to be variable F3 with pockets of F4 materials.
